## ZF4HP22

### EXTREMELY HARSH SHIFTS

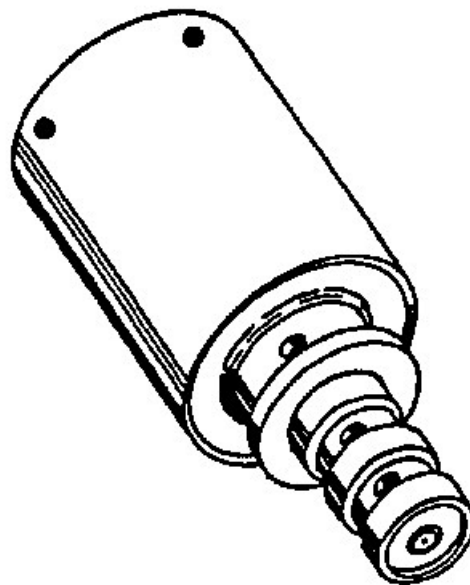
Figure 1

- COMPLAINT:** Harsh engagements and severe shifts while all shift speeds are okay.
- CAUSE:** Pressure Regulator “Force Motor” failure (See Figure 1). Extremely high pressure will result. This cannot always be diagnosed with an ohms test as the failure may be mechanical.

**PRESSURE REGULATOR “FORCE MOTOR”**

Pressure Regulator ohms test across both terminals should be 2.5 - 4.0 ohms resistance. This ohms test should be done near room temperature. Do not energize this force motor with full battery voltage as damage may result.

- CORRECTION:** Replace the Pressure Regulator “Force Motor”.
- NOTE:** A new Pressure Regulator from BMW is just under \$600.00 and is usually available in less than two weeks. There is, however, a suitable alternative that has proved most effective. The G.M. 4L80-E Force Motor is manufactured by the same company and aside from a few minor differences does the same job. Most of the overall dimensions are the same except that the G.M. 4L80-E Force Motor uses screens in the plunger and port areas (See Figure 2). Those differences are insignificant. A new 4L80-E Force Motor will cost you about \$133.00. The G.M. part # is 8677314.

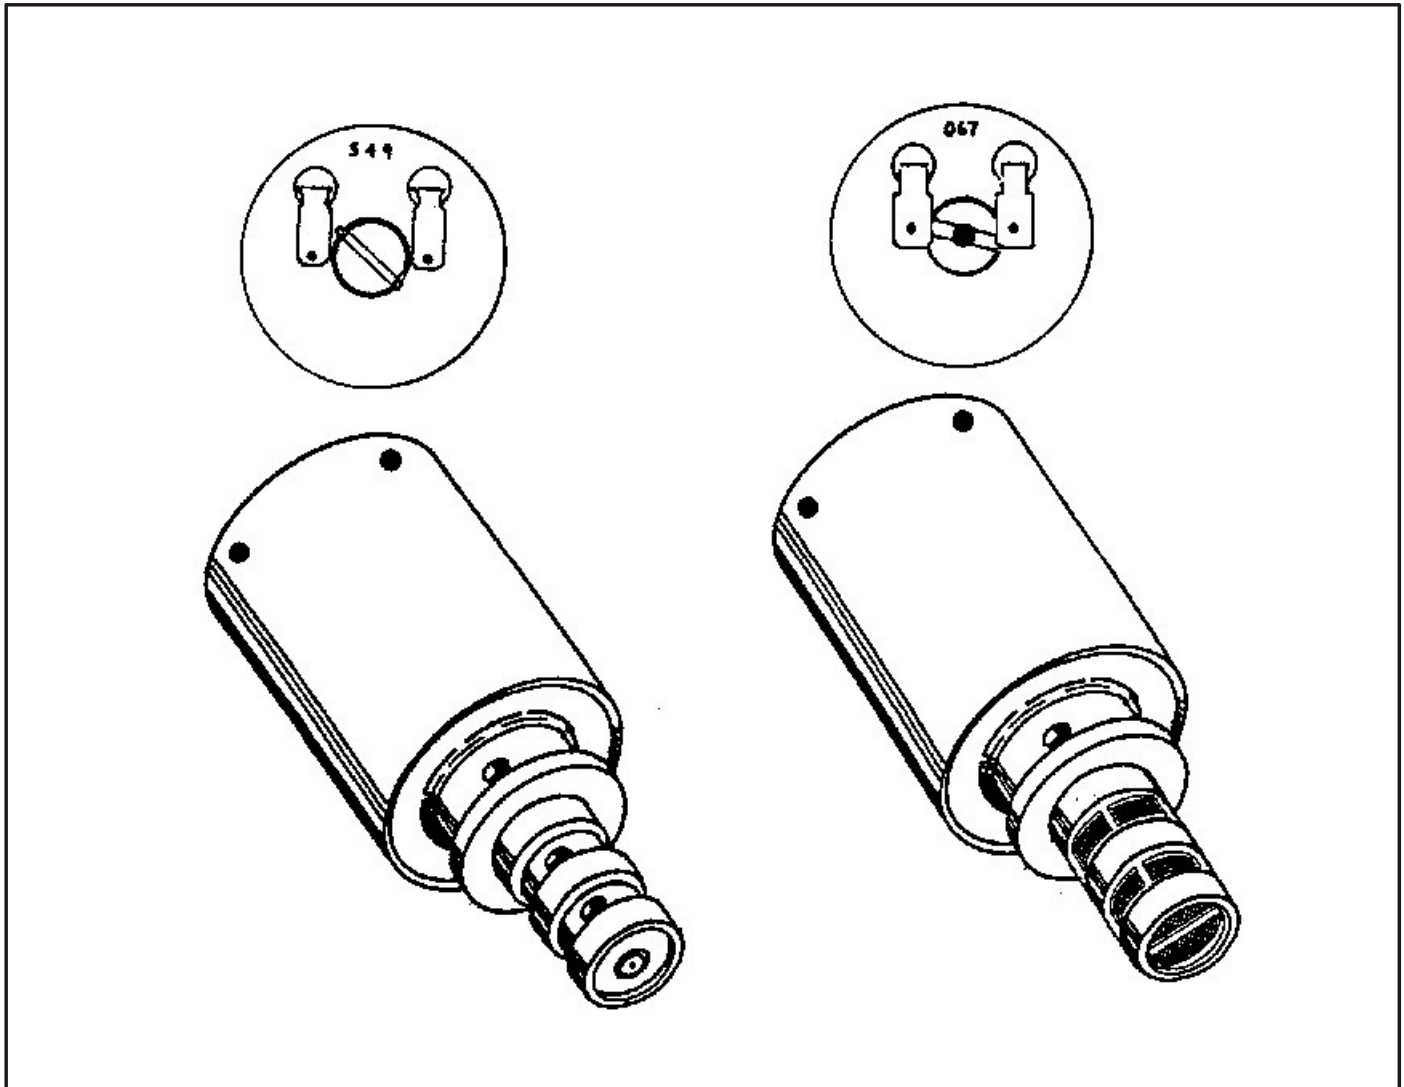
Figure 2

The BMW Pressure Regulator on the left uses no screens. The G.M. 4L80-E Force Motor on the right has screened ports and a steel ball pressed into the screw head to prevent tampering.
