ABS/ASC-T Pump Block Overhaul

Applicable to: 840ci (M60 & M62), 850ci (M73)

Oct 2011

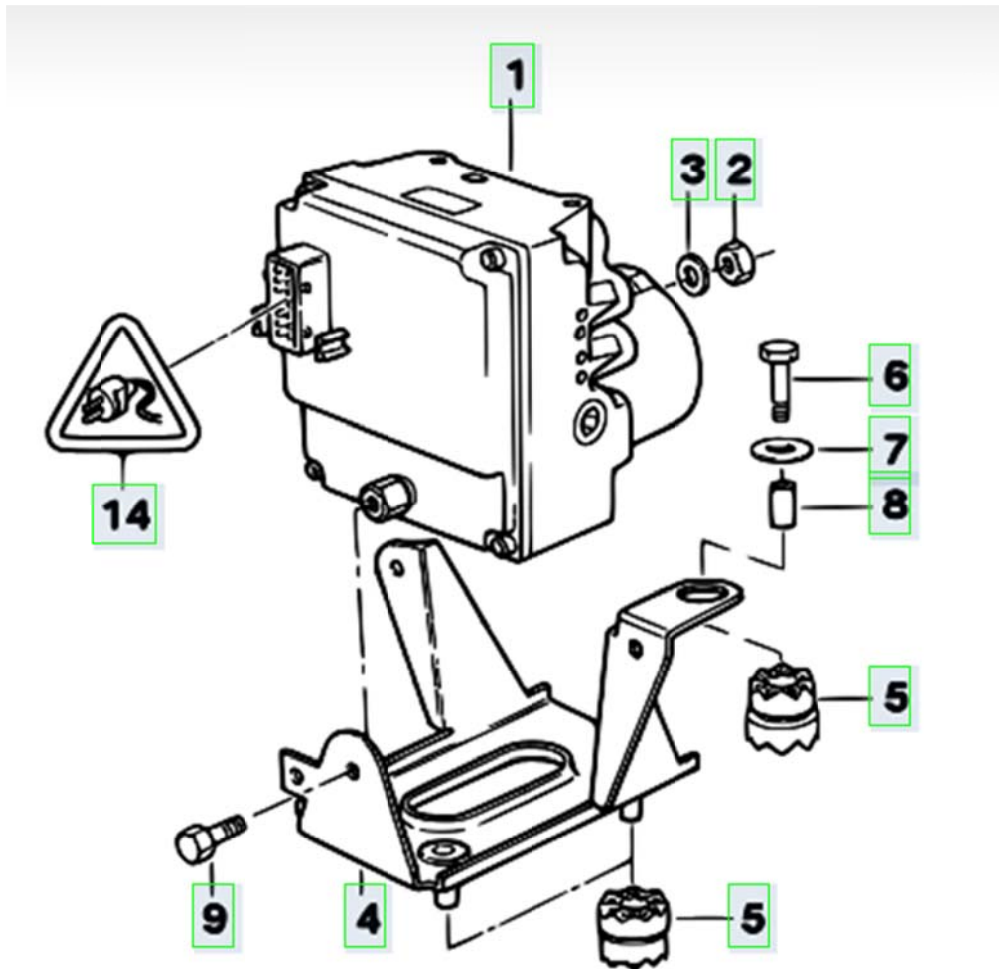
Location

The ABS pump unit (1) resides under the left-hand side wheel-arch plastic cover. As such, and particularly if the said cover is damaged or loose, a lot of dirt will accumulate on the unit. This is not helped by the fact that it is also more or less directly under the bonnet opening for the headlight unit, thereby being exposed to rain and water.

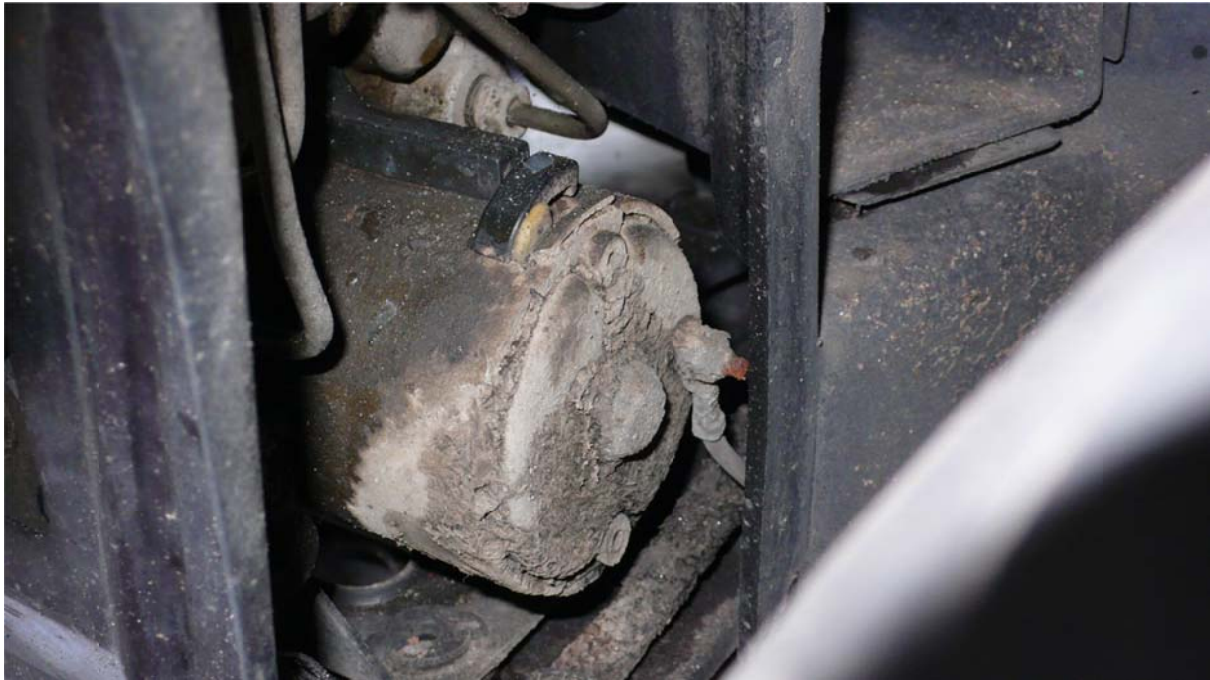
Picture-1: Before Cleaning. (The wheel arch liner does not offer good enough protection and the unit is also exposed to water and dirt from above, from the headlight openings.)

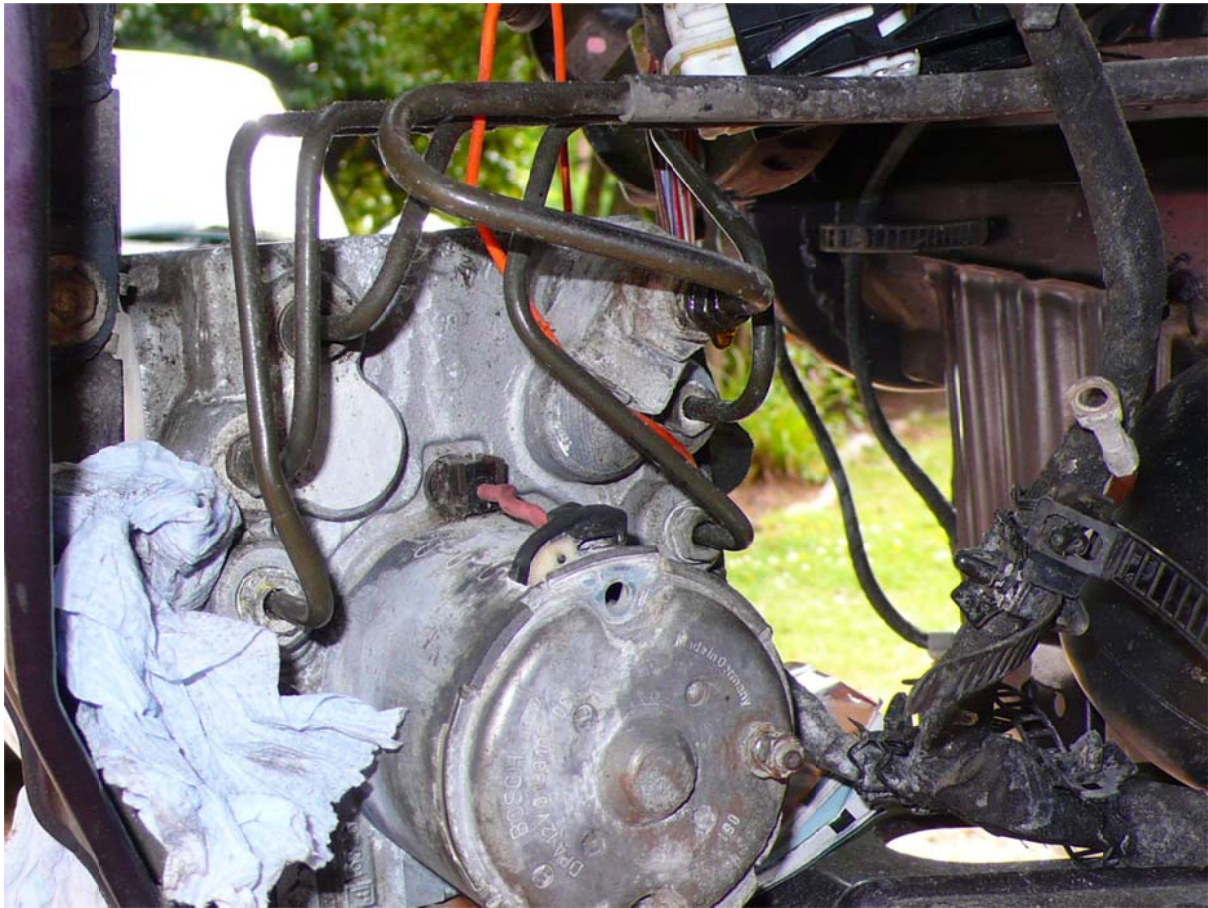
Picture-2: After initial cleaning (one Torx screw removed)

1. Clean the unit as much as possible, while still mounted on the vehicle. (Pic-2)
2. Disconnect the ground wire on the rear of the motor.
3. Disconnect the main cable connector from the front of the unit (slide-up locking mechanism).

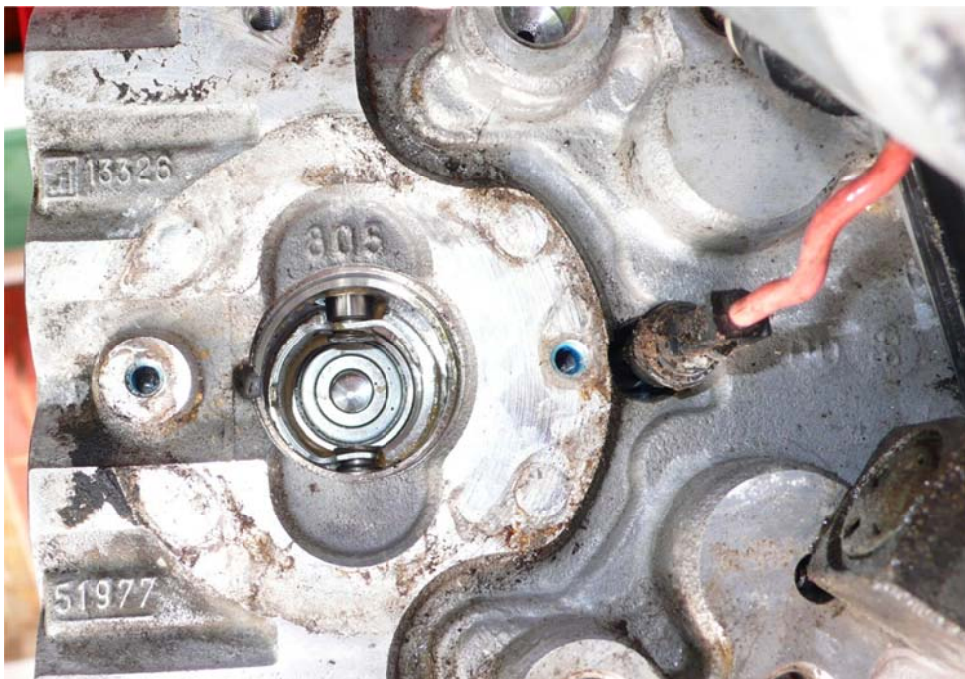
Picture-3: After removing the two motor Torx screws, and pulling off the black plastic cover along the top of the motor, the motor can be carefully extracted from the valve block.

8. After removing the two motor Torx screws, and pulling off the black plastic cover along the top of the motor, the motor can be carefully extracted from the valve block. (Pic-3). Note that the motor is still attached via the red wire.

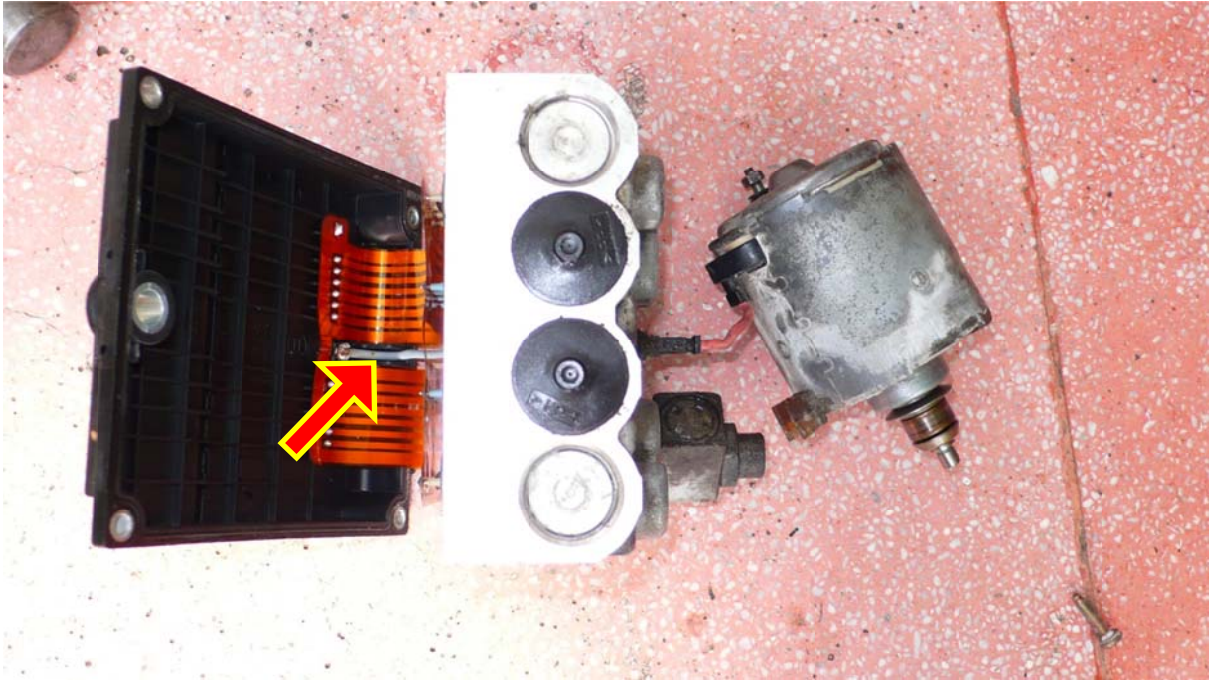
Picture-4: Carefully open the plastic cover. Note the grey wire.

9. Carefully open the black plastic cover on the front of the valve block (4 screws and one mount bolt) taking care with the internal flexible printed wiring. (Pic-4)

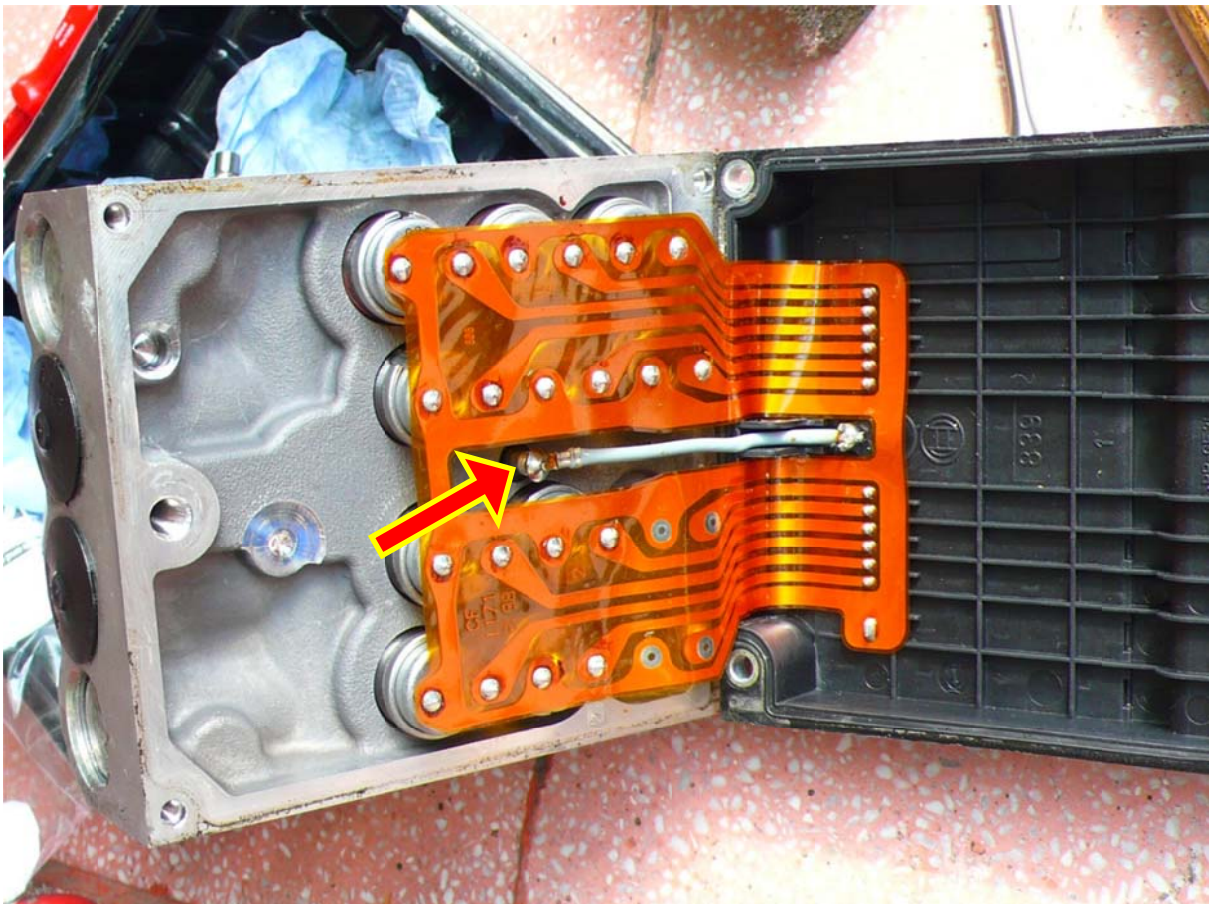
Picture-5: With a soldering Iron, disconnect the grey wire from the stud connector *on the aluminium block* (marked with arrow).

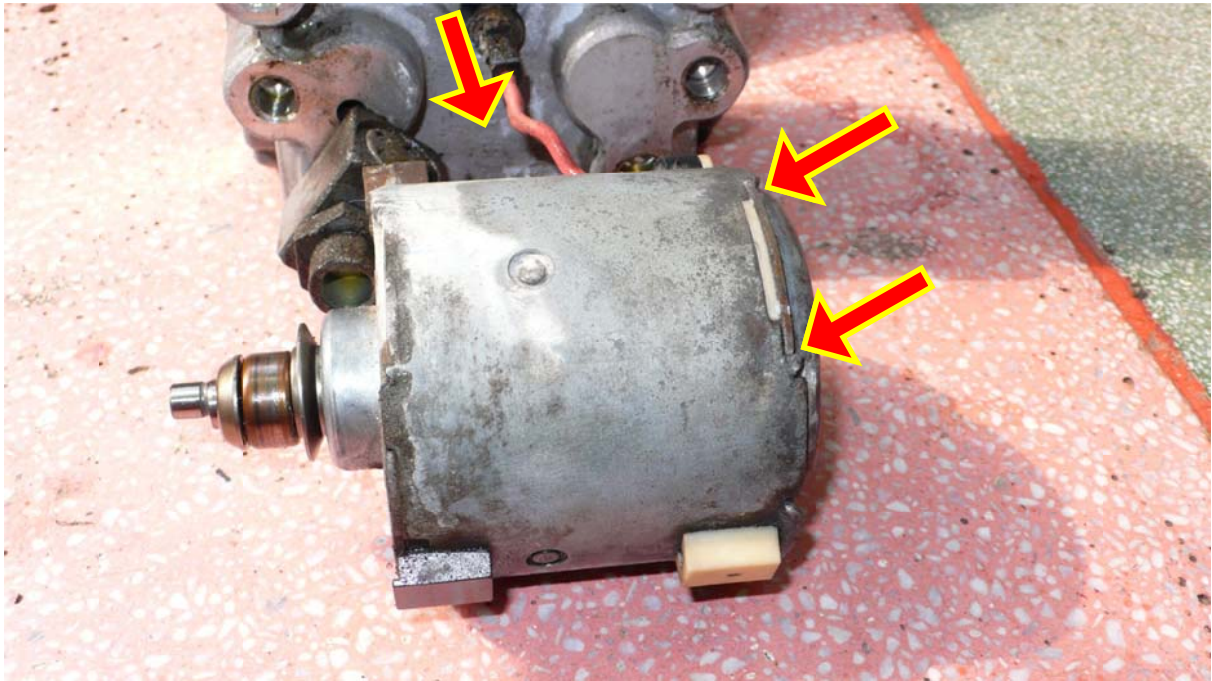
Picture-6: It is now possible to remove the motor from the valve block by extracting the connector terminal pin together with the red wire. To remove the rear cover of the motor, it is necessary to open up the peened-over crimps on the casing, in 4 places (two shown).

12. To remove the rear cover of the motor, it is necessary to remove the remaining nut from the rear ground stud and to open-up four peened-over crimps. These crimps can be opened up with a small chisel or similar. (Pic-6)

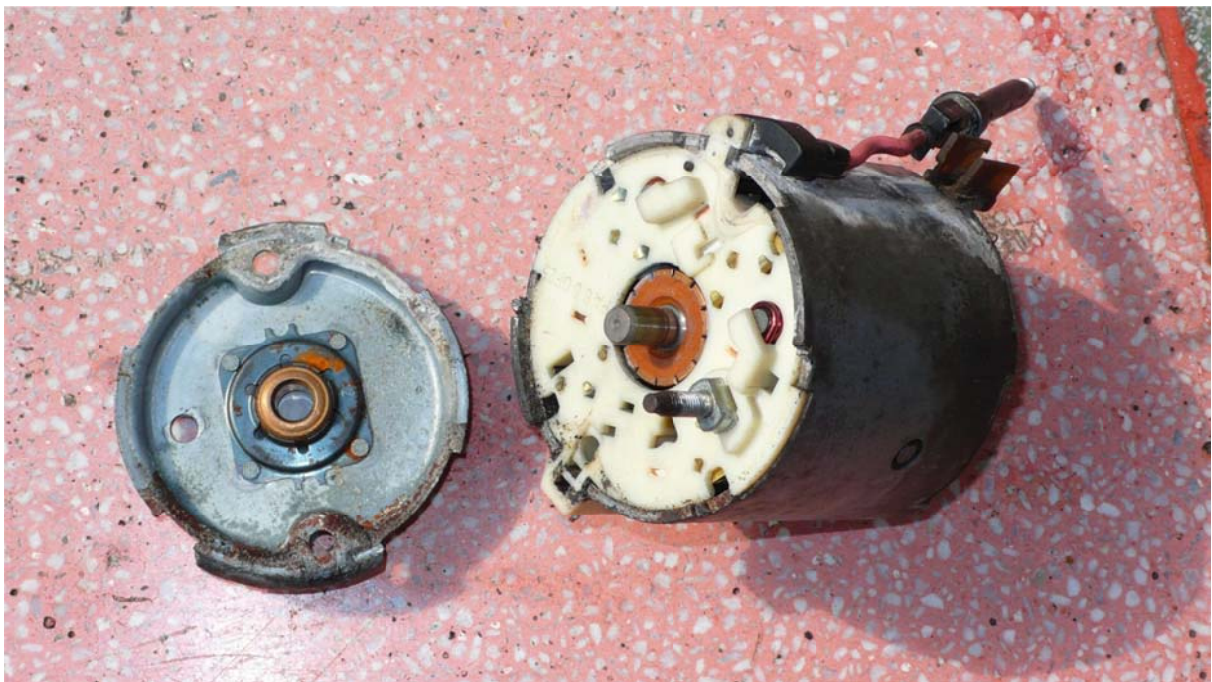
Picture-7: Motor with rear cover removed.

13. The rear cover can then be removed (Pic-7), revealing the white plastic brush-carrier assembly. This can be simply pulled out (Pic-8)
14. The overhaul of the motor will be covered in more detail separately, but briefly:

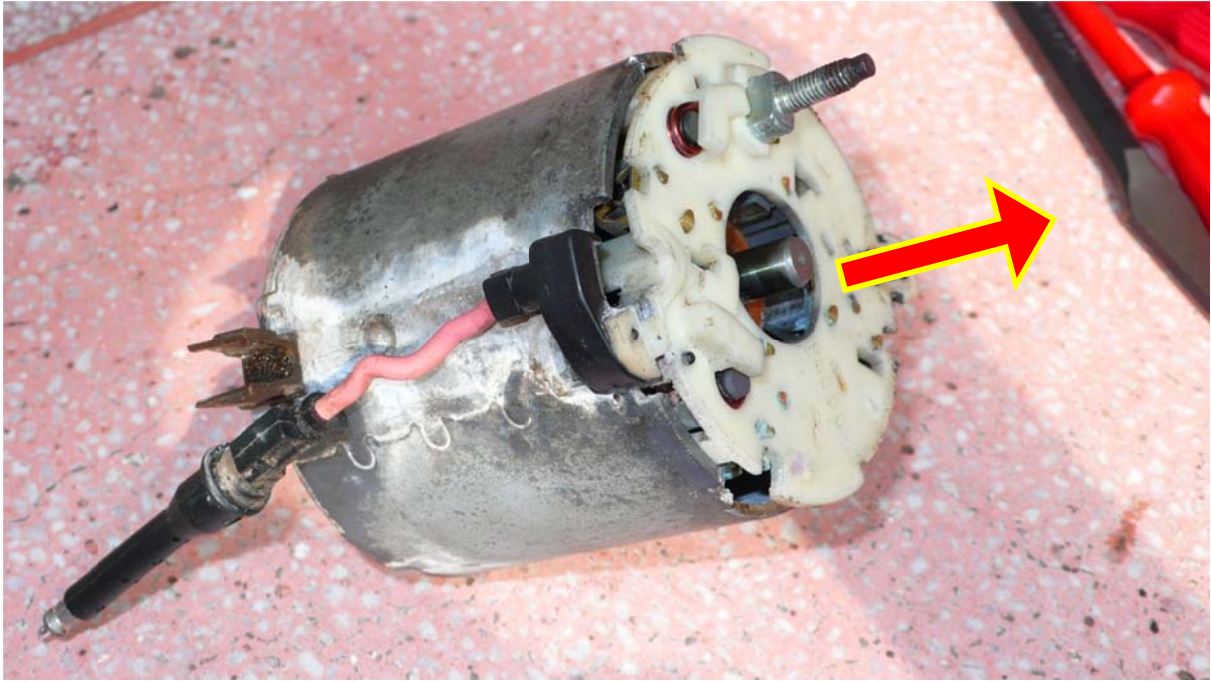
Picture-8: Brush carrier can now be slid out.

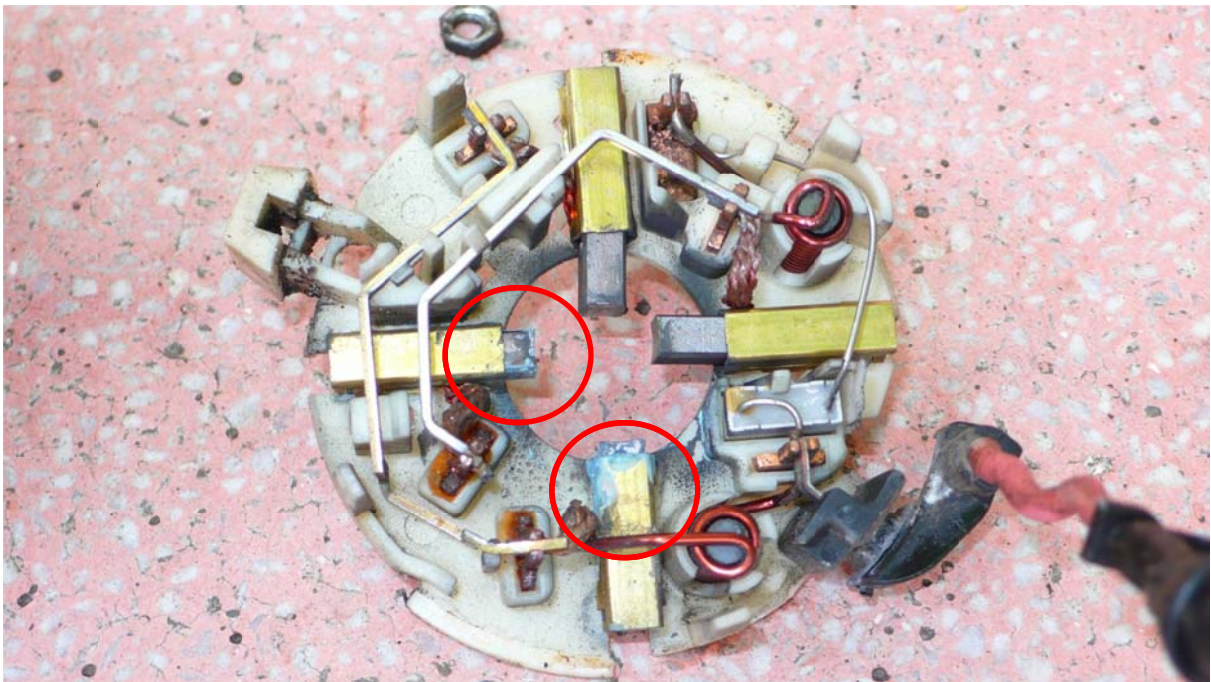
Picture-9: Brush carrier with 4 brushes (4-pole motor). Note that, in this case, at least one brush is stuck (bottom) and the other (left) is not looking too good either.

- d. Clean and grease the rear plain bearing
 - e. Clean the brush assembly with alcohol and apply a tiny amount of copper anti-seize grease to the brass brush holders.

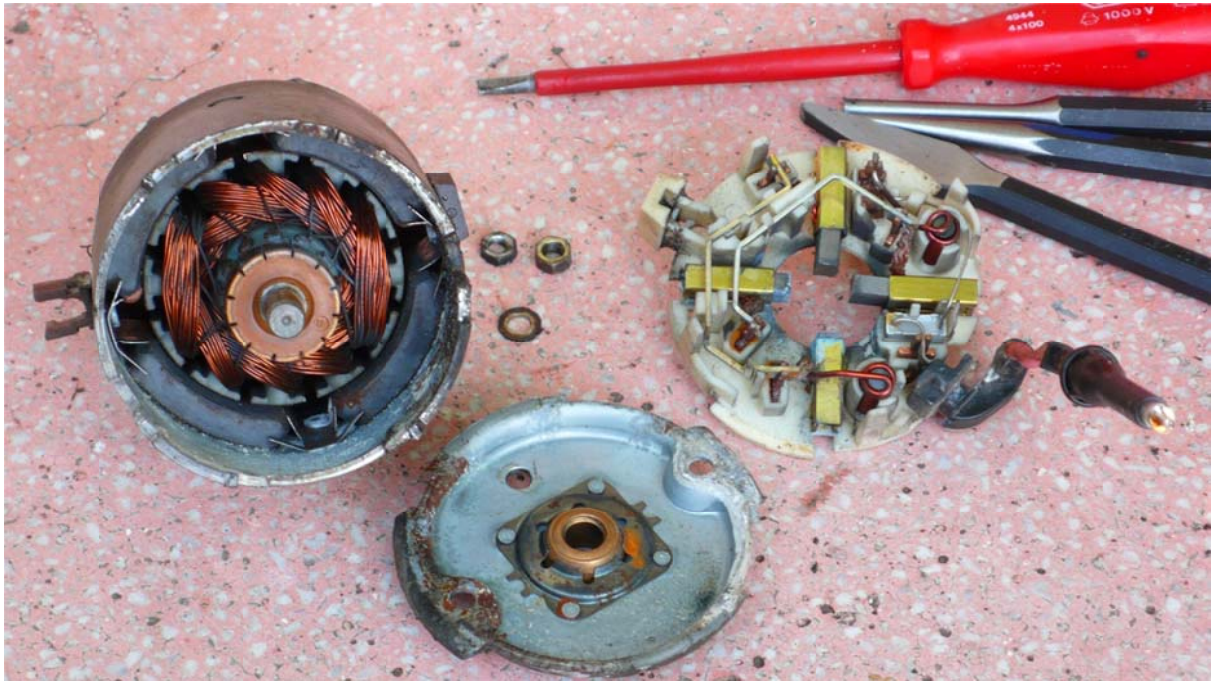
Picture-10: Motor with rear cover and brush assembly removed.

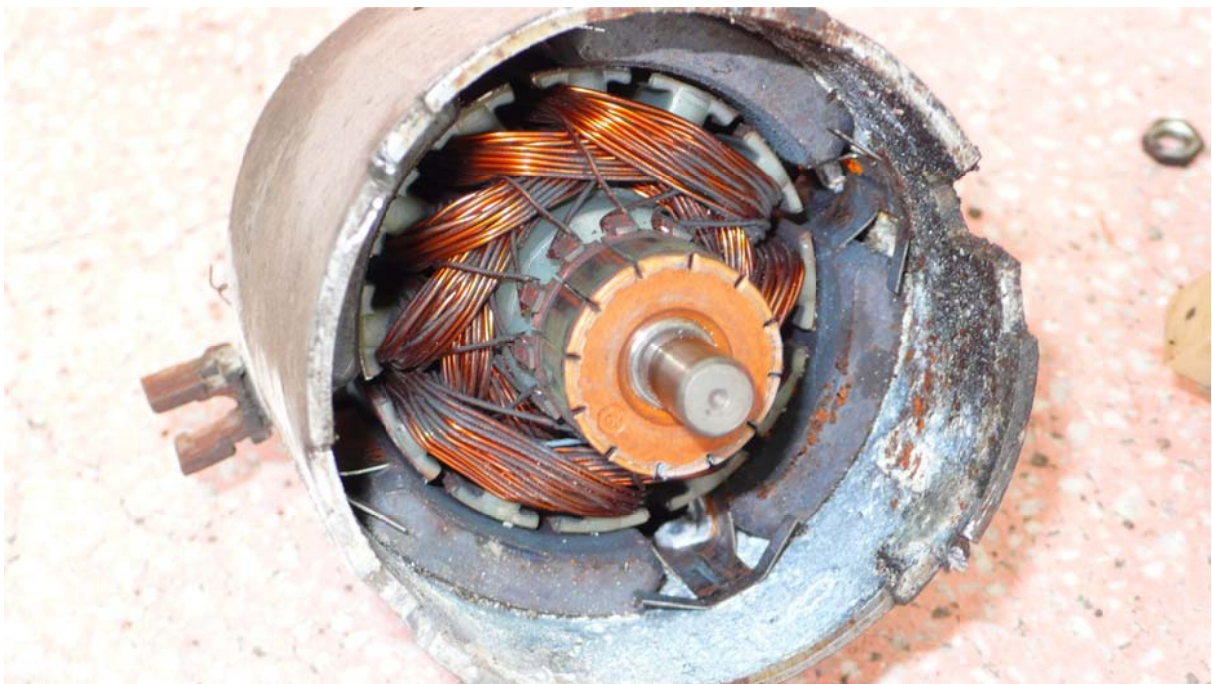
Picture-10: Motor commutator and windings could do with a clean. Note ceramic magnets are held in by spring-clips

- a. Clean the windings with some alcohol
 - b. Clean the commutator ring with fine emery or wet-n-dry paper.
 - c. Check that the front bearing rotates freely. Try clean with alcohol and oil if gritty.

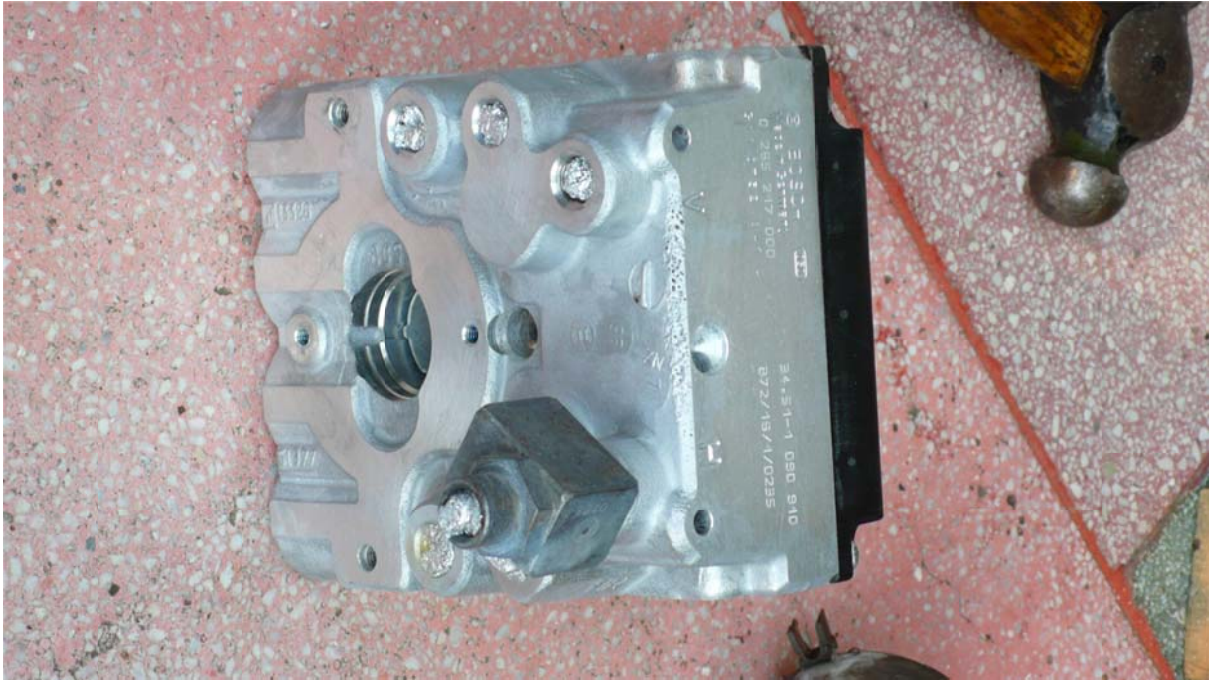
Picture-11: The valve-block is further cleaned with alcohol and/or metal cleaning solution.

- g. Otherwise, reassemble the motor.
 - h. Lightly grease the front eccentric cam- ring ready to replace into the valve-block.
15. The valve-block can then be carefully cleaned using alcohol (Pic-11), or for more severe cases a solution such as POR-15 Metal Prep works well, but try to keep this away from the pump mechanism and bearings (Pic-12).

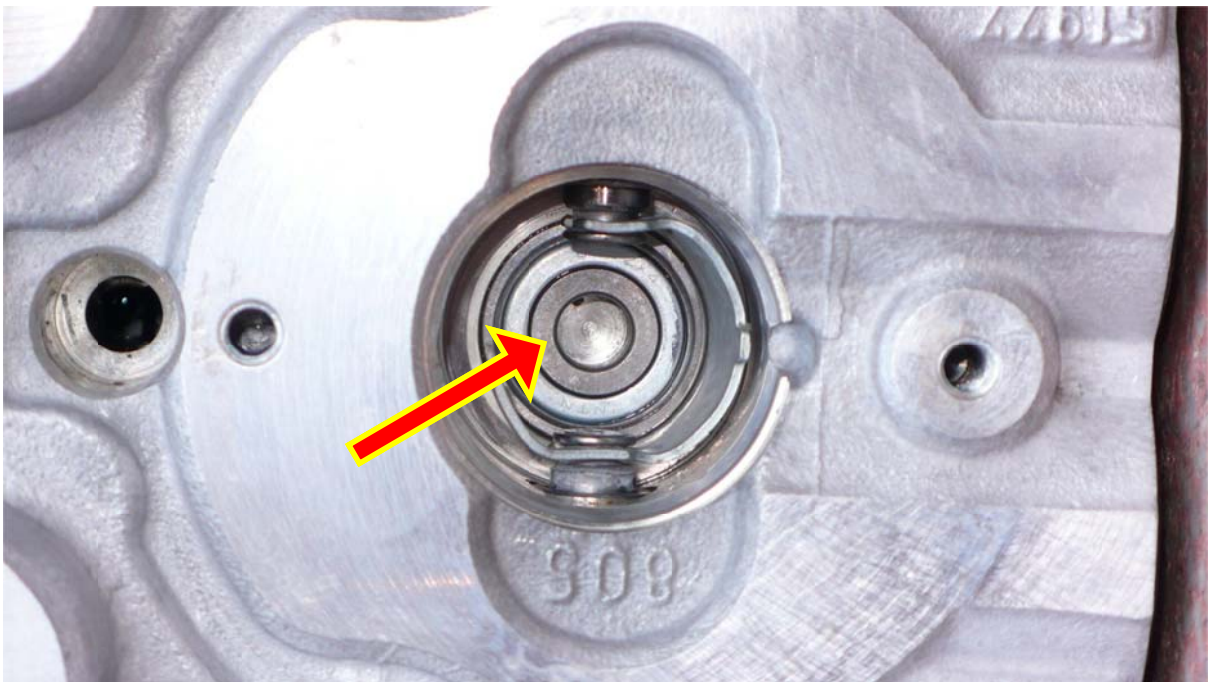
Picture-12: it was noticed that the support bearing for the pump mechanism was partly seized.

16. Check that the pump bearing is not seized (Pic-13)
17. Re-grease the pump bearing and mechanism with general-purpose (light) lithium grease.
18. Replace parts in reverse order to removal.

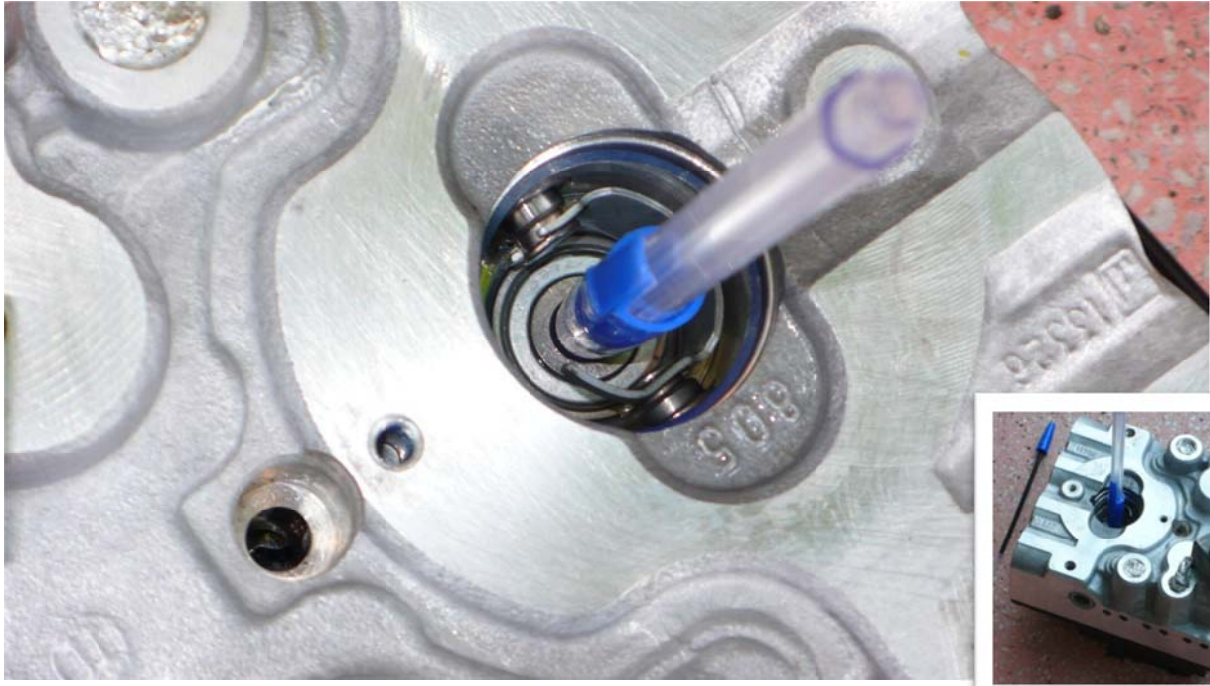
Picture-13: using some WD-40 and the end of a *Bic* biro to rotate it, it was freed-up and some Isopropyl alcohol was then used to clean it.

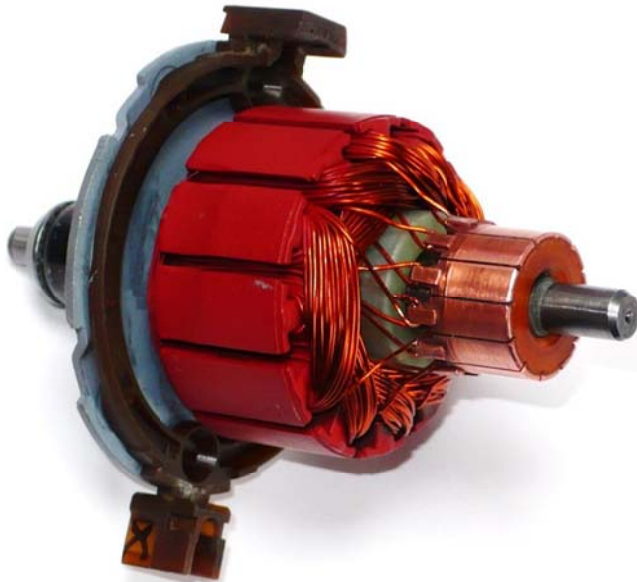
Picture-14: Clean the motor armature with isopropyl alcohol or similar and use fine emery or wet-&-dry paper to clean the copper commutator. Here, the laminations are also painted in red primer and the windings have been re-varnished. Ensure that the front bearing spins freely.

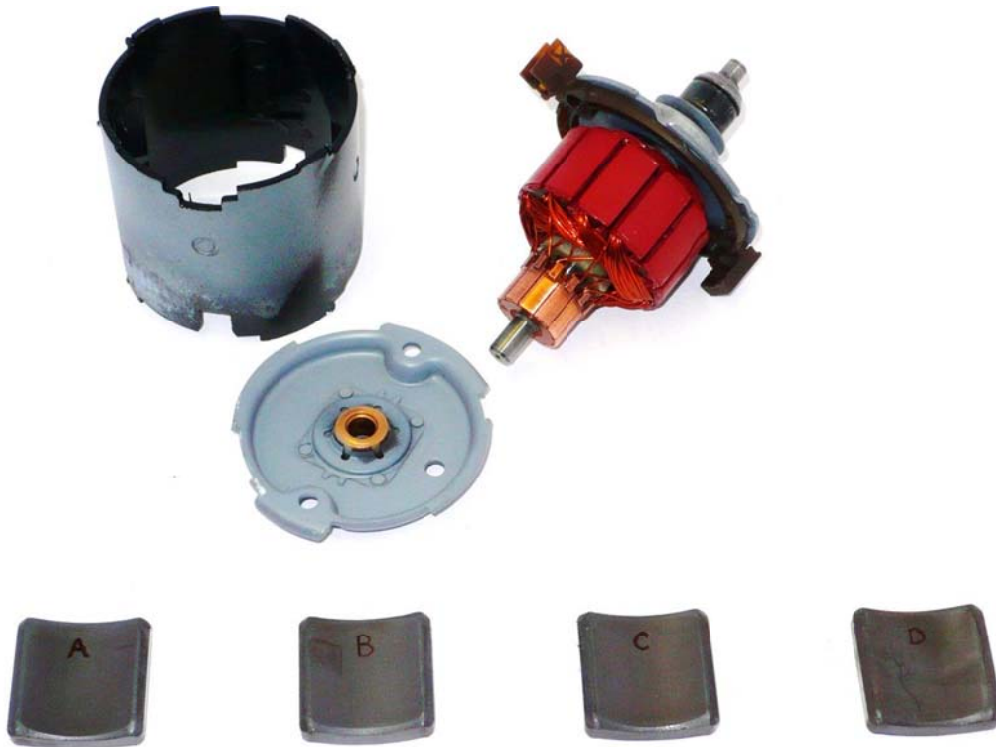
Picture-15: Slide out the magnets from the stator, but as they are alternate N and S poles, label each with a permanent marker and also place a corresponding label on the outside of the stator tube. [!!! Keep magnet apart from each other or they could collide with each other and crack !!!]

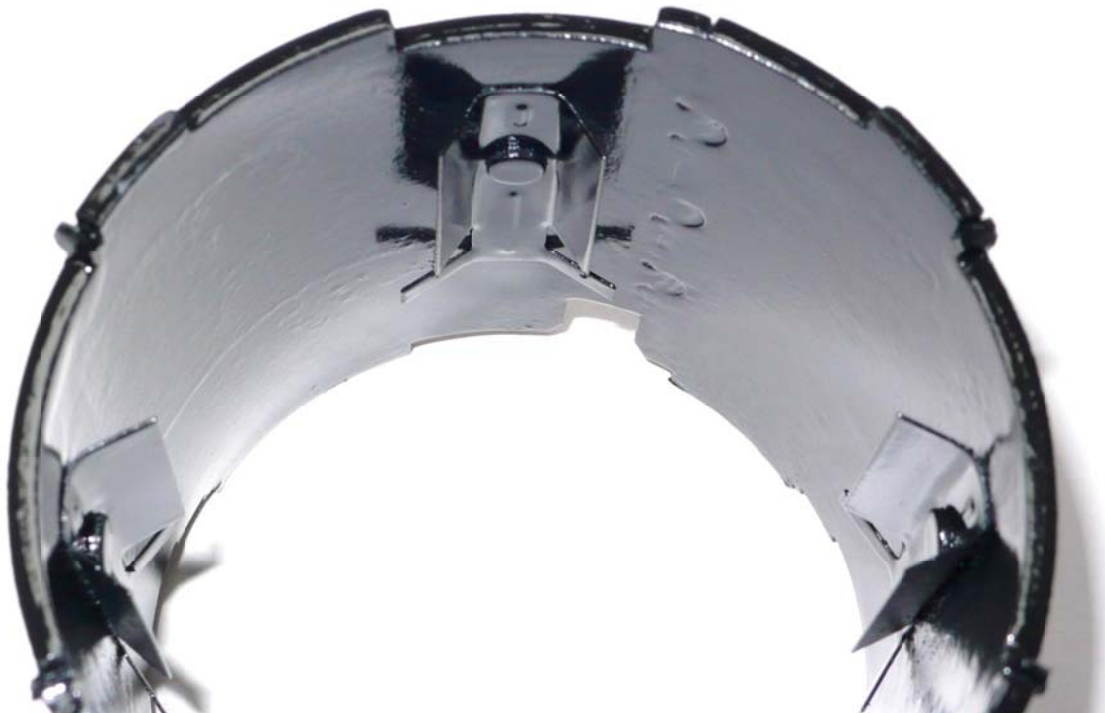
Picture-16: Clean and paint the inside of the stator tube (note the clips which retain the magnets).

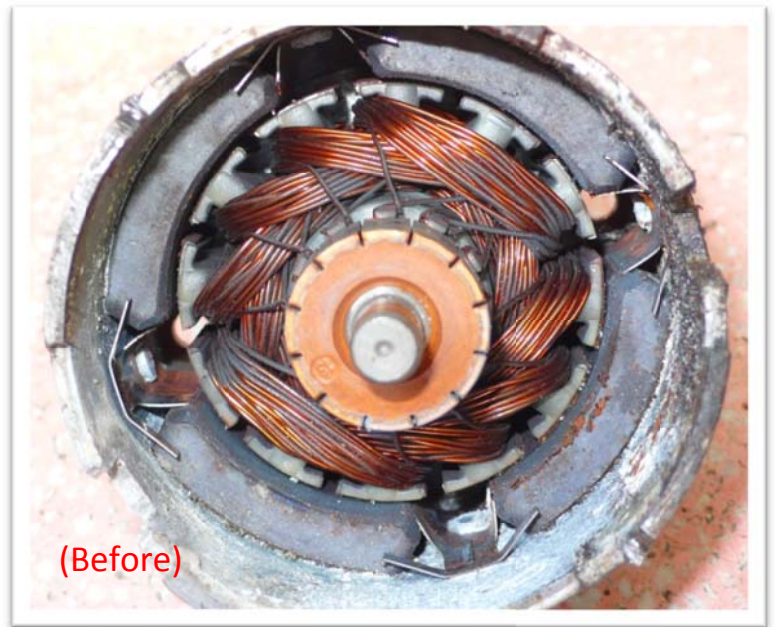
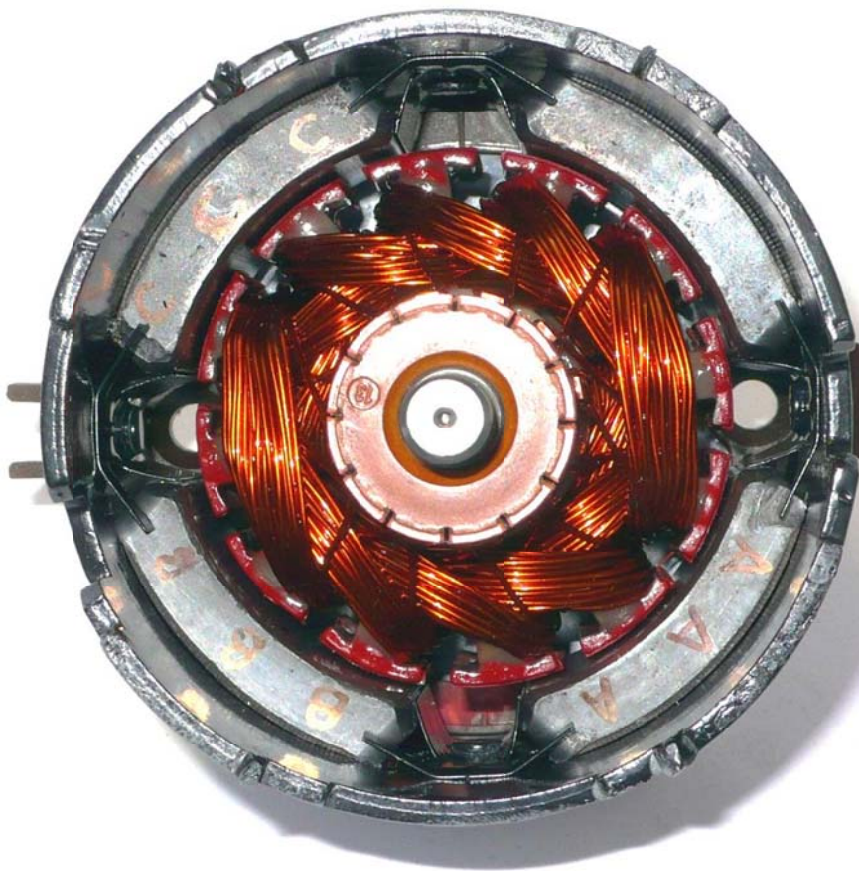
Picture-17: Refit the magnets and refit the rotor armature. Re-assemble the motor with the cleaned brush assembly. The front motor bearing is difficult to access and was lubricated with a few drops of engine oil. The rear bronze bush was lubricated with some lithium grease. Here the motor end-casings were not re-crimped as, when refitted, the tie-bolts are adequate to keep the whole thing together and it permits easier future servicing.

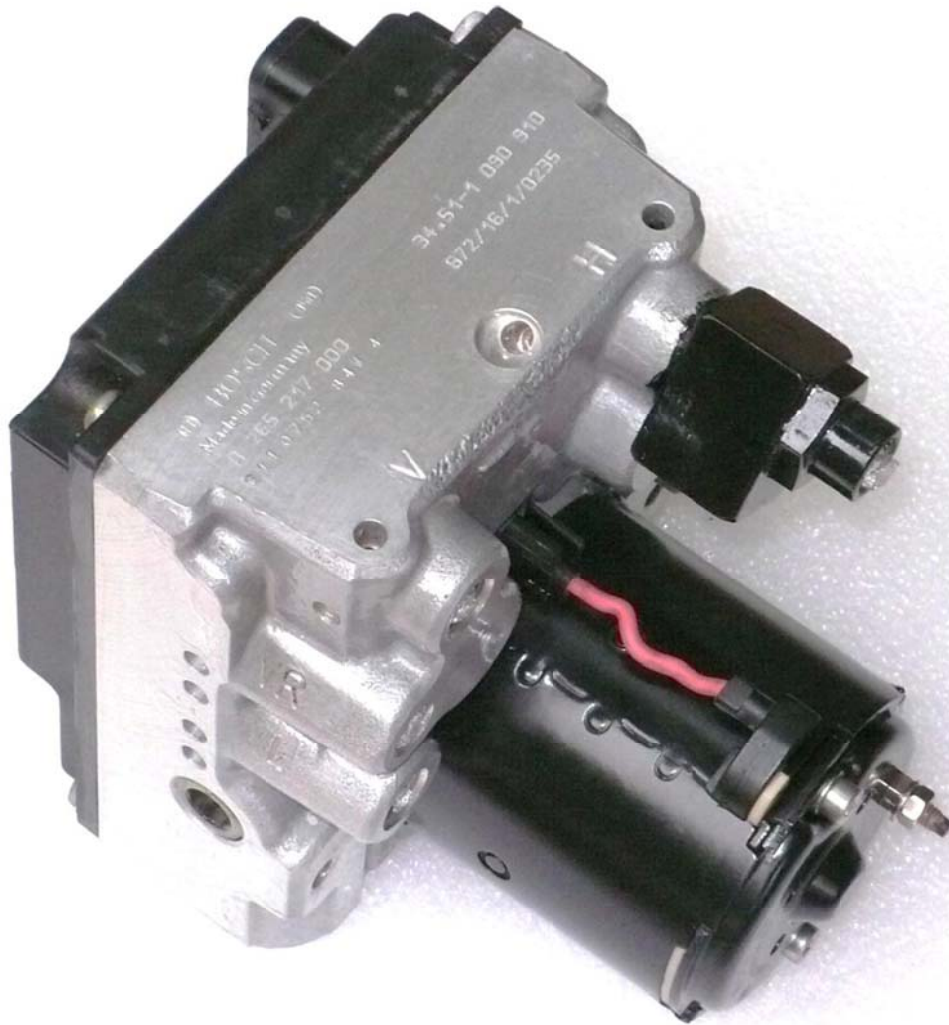
Picture-18: The exterior of the motor is painted with black epoxy paint and then fitted to the valve-block. Before fitting, some grease is applied to the valve-block bearing and mechanism and motor spindle. (The valve-block itself was painted with a clear, 2-part epoxy varnish.)

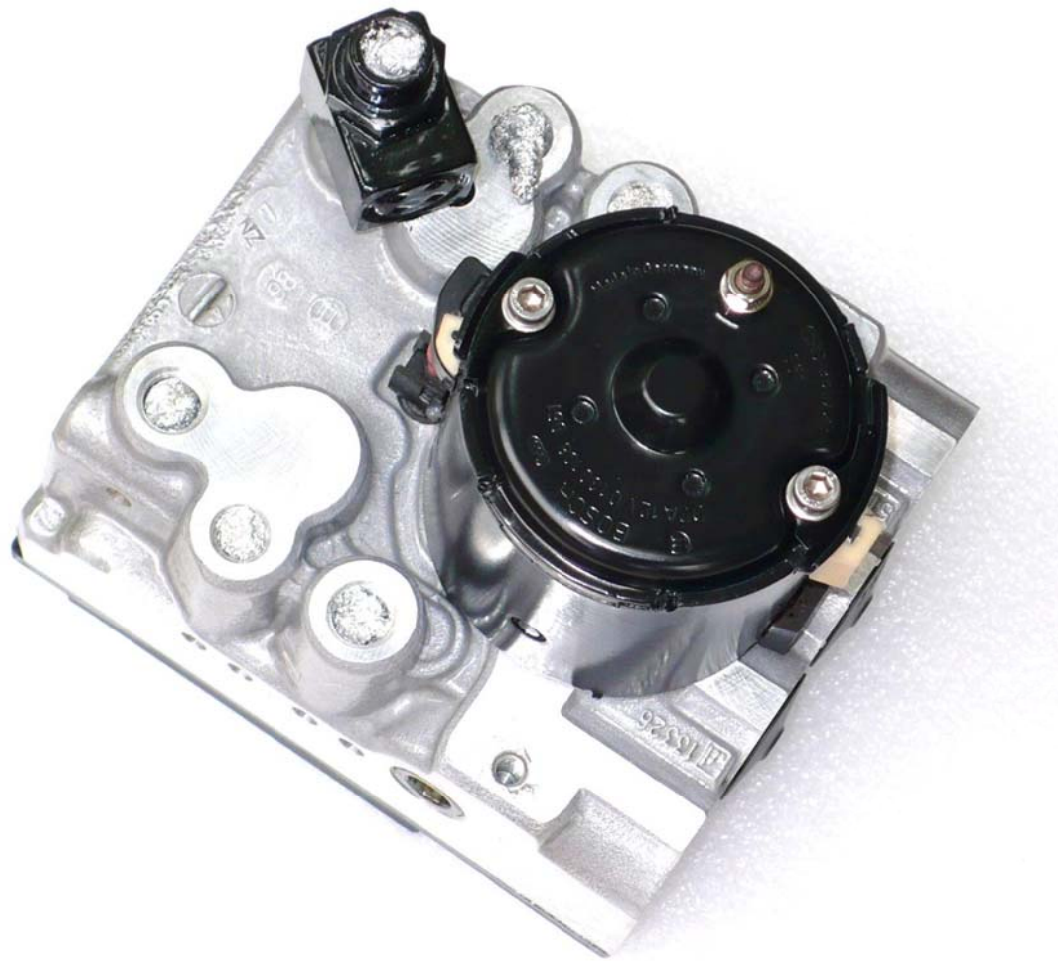
Picture-19: The original Torx-head screws are replaced by two stainless-steel hex-socket screws.

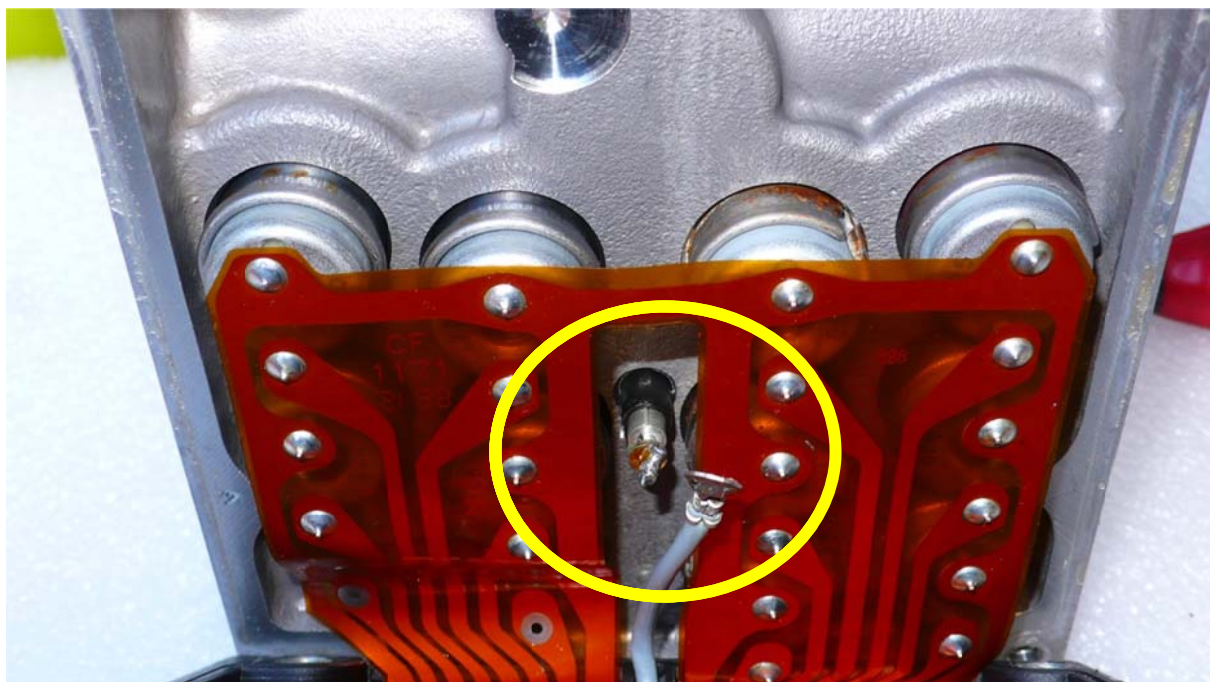
Picture-20: Don't forget to re-solder the motor wire into the valve-block.

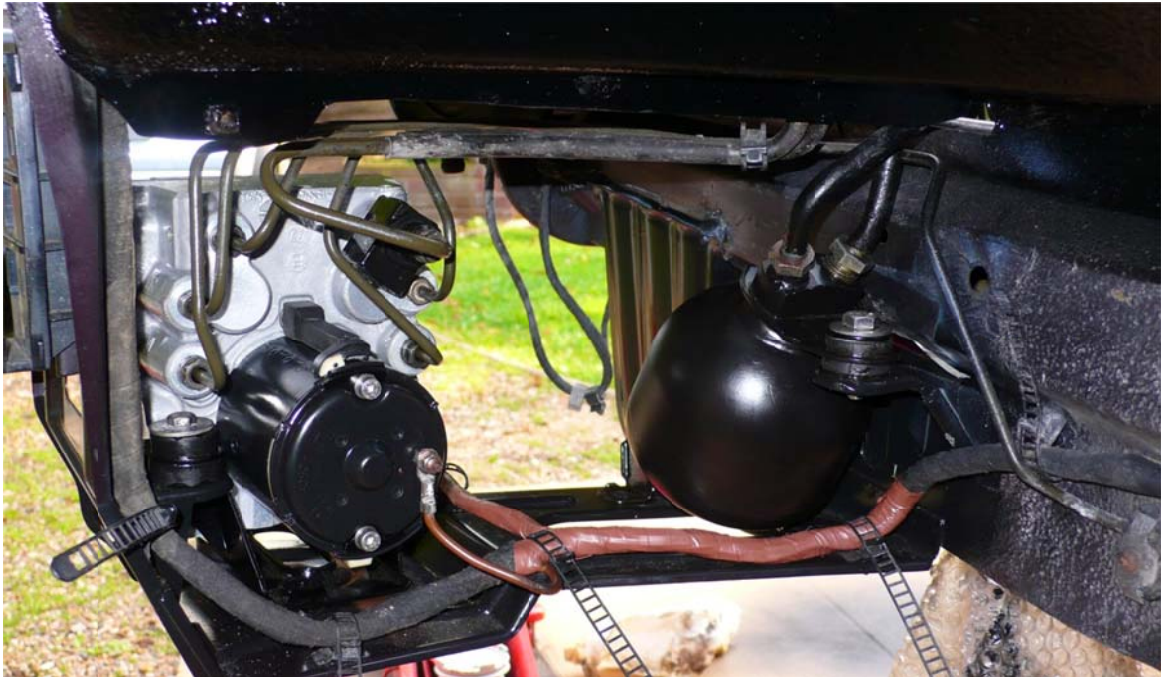
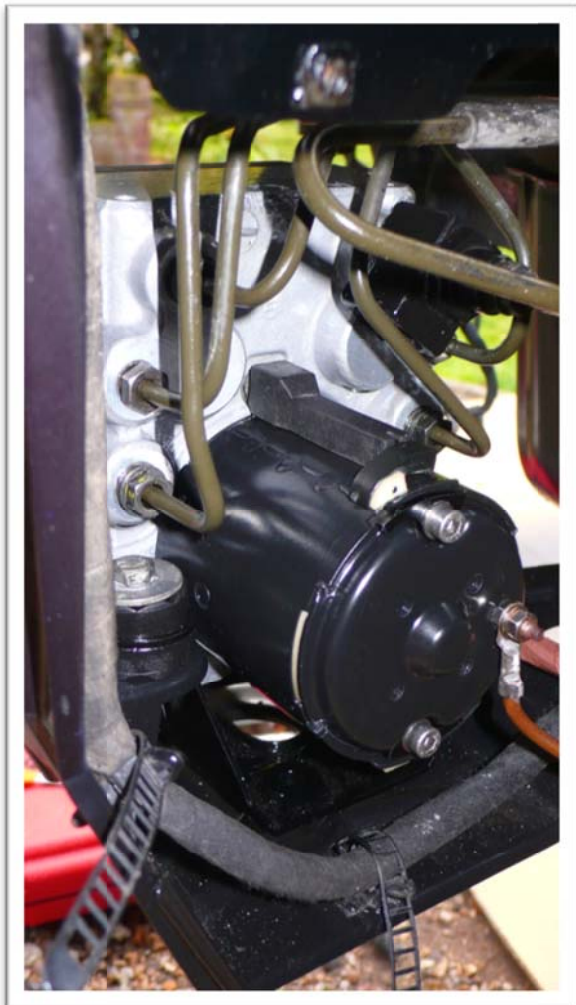
Picture-21: The unit is refitted in the same manner that it had been removed.

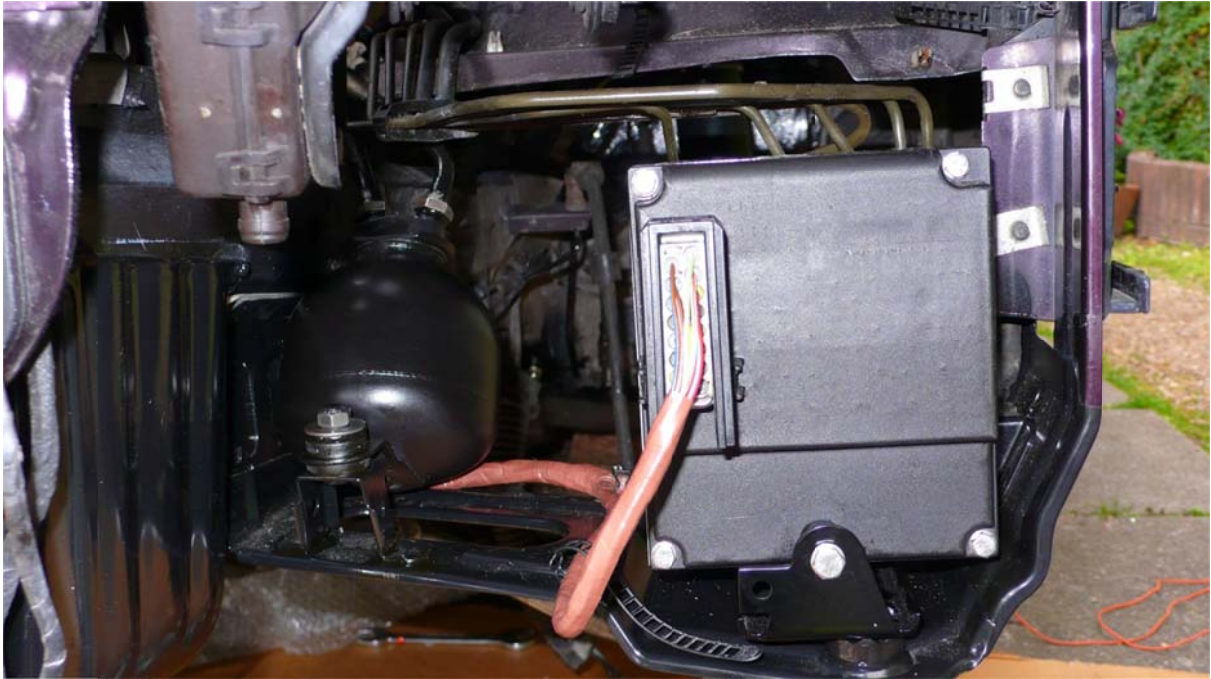
Picture-22: Clean, lubricate and refit the main wiring connector.
