ABS/ASC-T Pump Block Overhaul

Applicable to: 840ci (M60 & M62), 850ci (M73)

Oct 2011

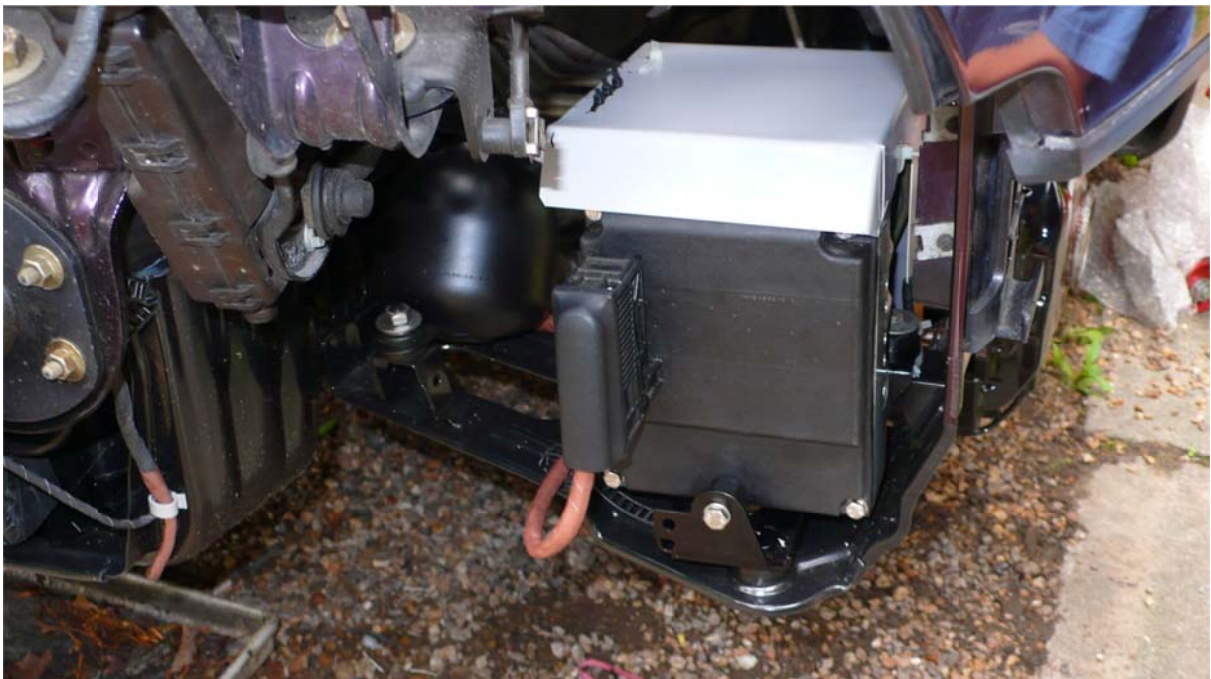
Picture-23: A cover made of thin sheet zinc is added to protect the ABS unit from rain and dirt. The cover is secured to the hydraulic lines on one side and to the chassis on the other using cable-ties.

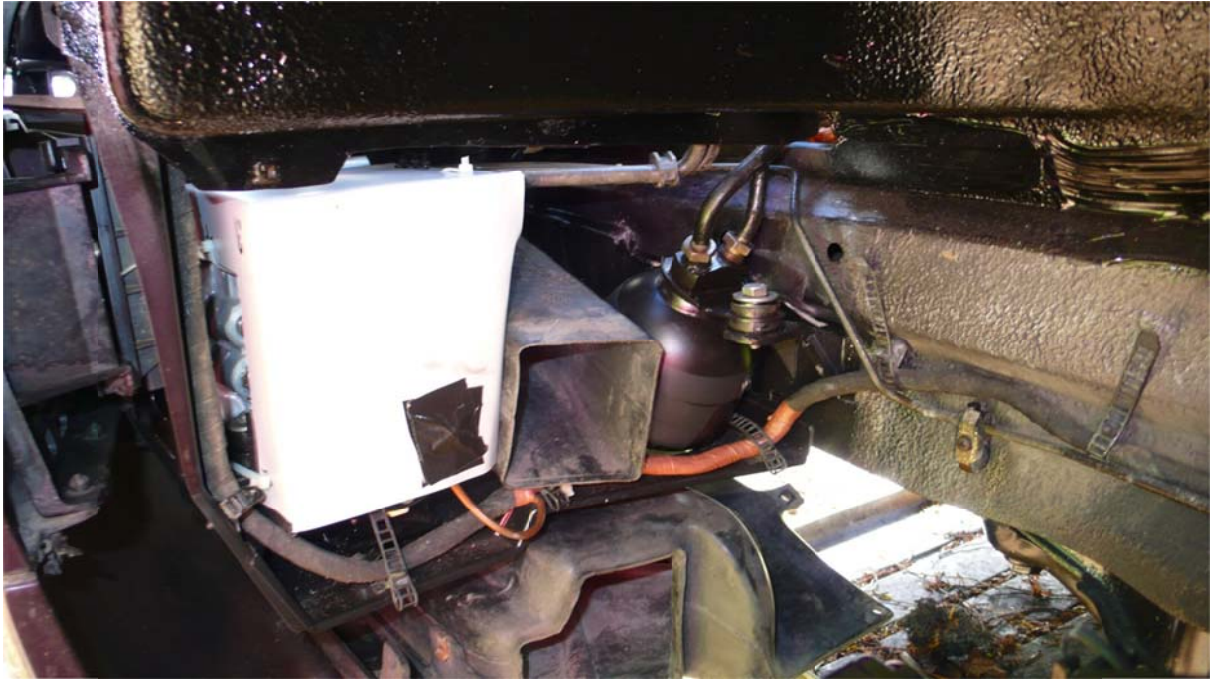
Picture-24: The cover extends down to the rear.
