Electric rear blind repair

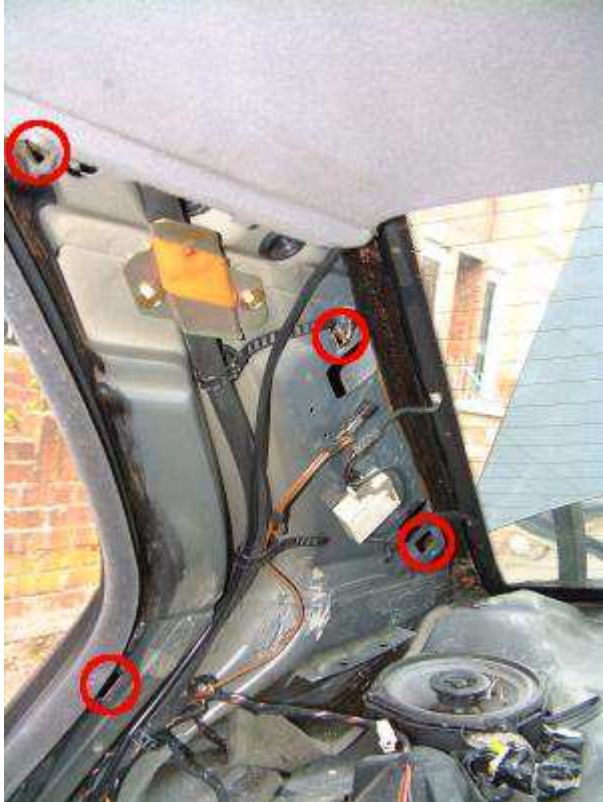
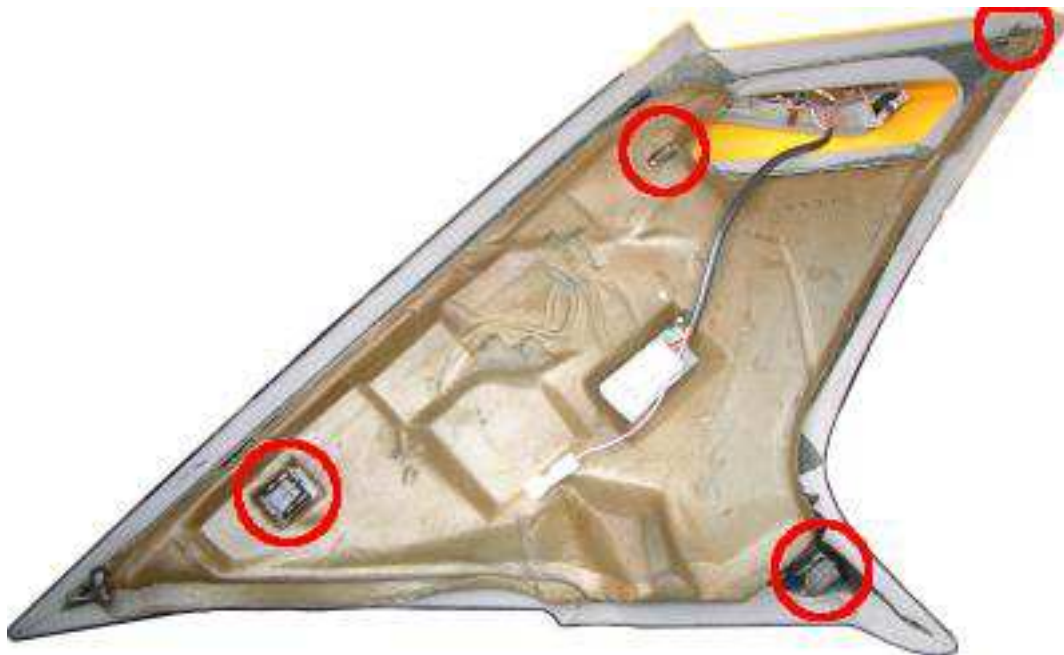
Remove the two trim pieces either side of the rear window. To do this, first pry out the interior lights, using a flat screwdriver behind the rear edge. Next put your hand in the hole and pull gently but firmly away from the car body. You need to pull the top away first, then the bottom will pull up. You might need to ease it past the trim around the door opening.

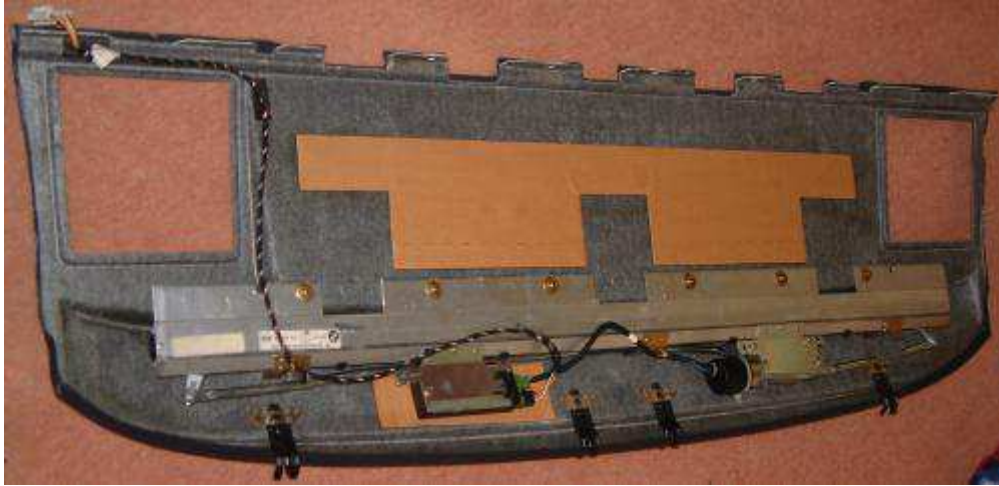
Pop out the 4 plastic clips on the front edge of the parcel shelf, unplug it from the car (a 4-way plug on the right hand side, near the right speaker), and carefully pull it forwards and out of the car. Put it down somewhere upside down and examine the mechanism. You should find an electrical control unit, connected to a small motor and gearbox. The output shaft of the gearbox is connected to a plate which has two arms connected to it, one for each actuating arm for the blind. When the shaft rotates the arms are pulled towards each other, which raises the blind, or are pushed away from each other to lower it.

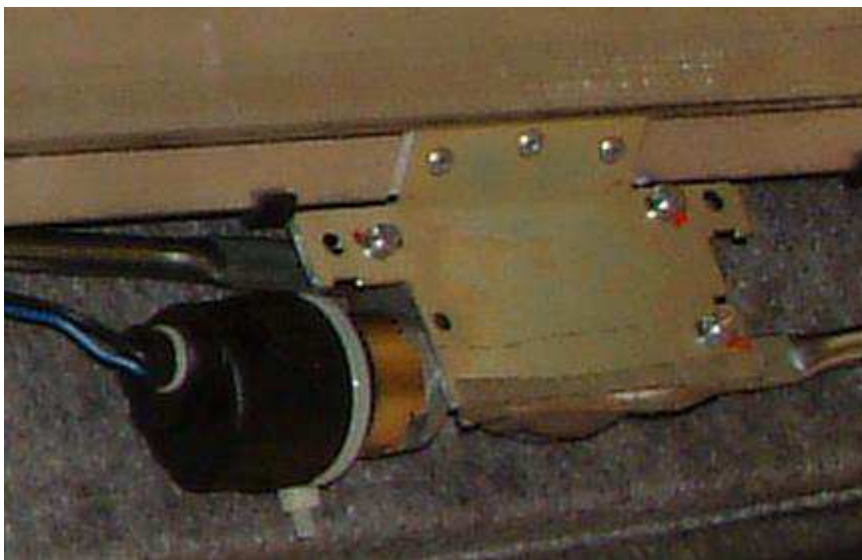
Unplug the motor from the control unit. Cut through any cable ties securing the wire to the shelf. At the far end of each arm, pry off the one-way washer holding it to the actuating arm. Mark the position of the 3 screws on the rear of the motor mounting plate and remove the screws. The gearbox can be removed from the shelf with the arms still connected, the longer one has to be carefully threaded out.

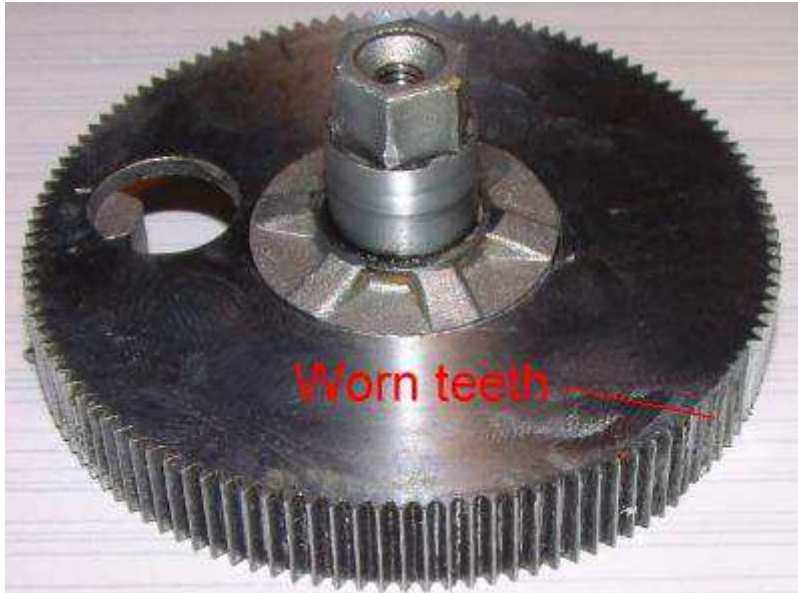
smaller gear. While holding it in that position, pull out the smaller gear. Then carefully unwind the spring by rotating the gear clockwise. Pull out the large gear and rescue the spring from underneath. Clean all the grease off them so you know what you're looking at. Run something down the gap between each pair of teeth on the gear to clean it out. You will find a section of teeth has all but gone, this is the section causing all the noise. You need to arrange things so that this section is never used.

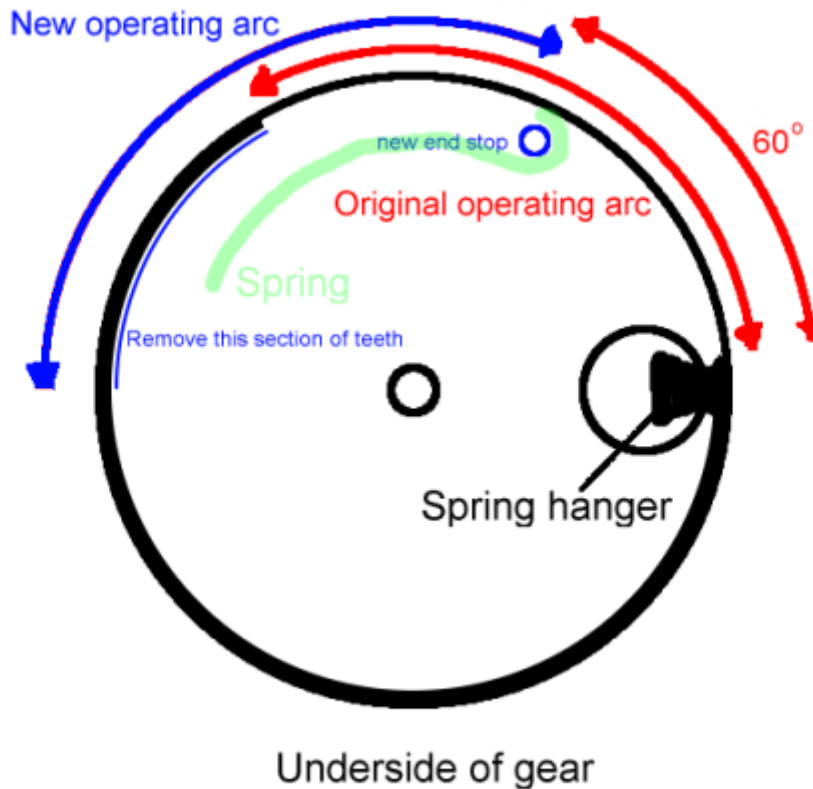
Note the output shaft of the gear. It has a hex end on it, so each face is at a 60 degree angle to the next. Because we want the output wheel to start and end in the same relative position as before, we need to use a section of gear which is a multiple of 60 degrees away from the section it was originally using. See diagram.

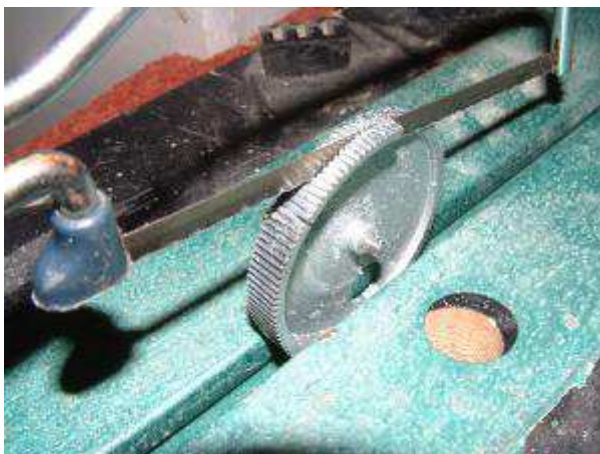
Note the thickness of the edge of the gear. There is a thin section where the end stop screw runs. It goes from the point where the spring hooks on, to a point approximately 120 degrees further round. This thin area has to be extended by 60 degrees. Clamp the gear in a vice and remove a section with a hacksaw, then clean up the edge with a file.

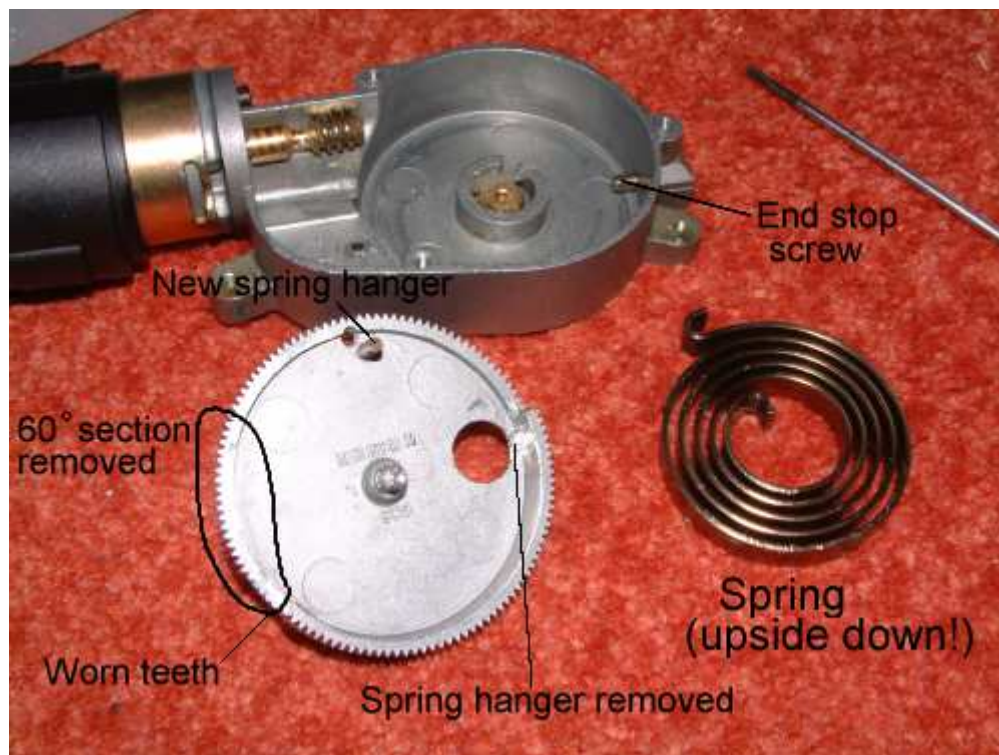
The point where the spring hooks on also has to be moved 60 degrees round the gear, and the old mounting hook has to be removed. I removed it with a cutting bit in my mini drill. The new mounting point can be created by drilling and tapping a small hole in the gear, then driving a machine screw through the hole to form a peg for the spring. Remember, this peg is also the end stop, and you will probably find that the end stop screw in the gearbox casing is

not long enough to reach it. You will need to replace the end stop screw with a slightly longer one. NB the other hole near the new spring hanger, in the picture, was an earlier attempt at a different fix method. You can ignore it.

Put a bit of grease on the spring and replace it back behind the gear, in the same orientation as it came out (shown in the diagram in green). NB it is upside down in the picture, with respect to the orientation of the gear. The diagram is correct. Put a bit more grease around the teeth of the gear, align it with the gearbox and replace it, remember the centre of the spring has to line up with the centre spring hanger.

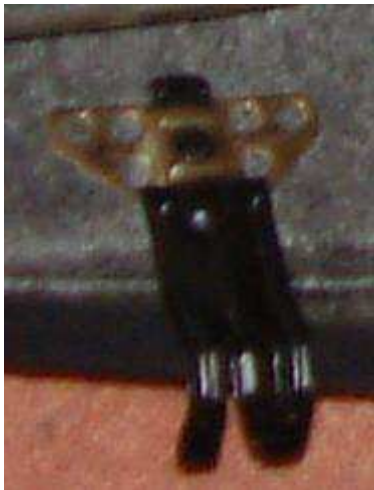
Assuming you are happy with the state of affairs, replace the two one-way washers on the actuating arms, plug the motor back into the control box, and secure the cable with a cable tie. Refit the parcel shelf into the car. At the rear edge of the parcel shelf are 4 metal clips, these sit in holes near the rear window and used to rattle in my car. On examining the holes I saw that one of them had felt tape stuck around the top, the others were bare metal. I made some more tape with some black material and some double-sided sticky tape, and applied it around the other three holes. No more rattle.
